LEAD-BASED PAINT EVALUATION REPORT HAZARD REDUCTION CLEARANCE

Monmouth Day Care Center
9 Drs. James Parker Boulevard
Red Bank NJ 07701

Inspection Date: 4/22 & 5/4/2021
Project Number: 210284 & 210322

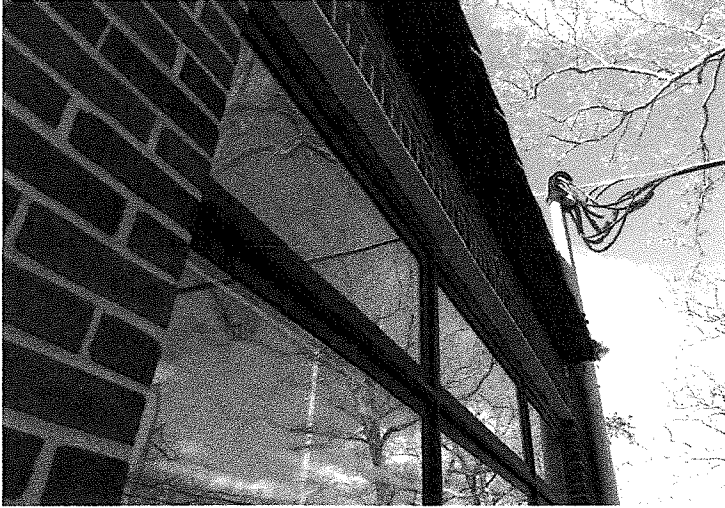
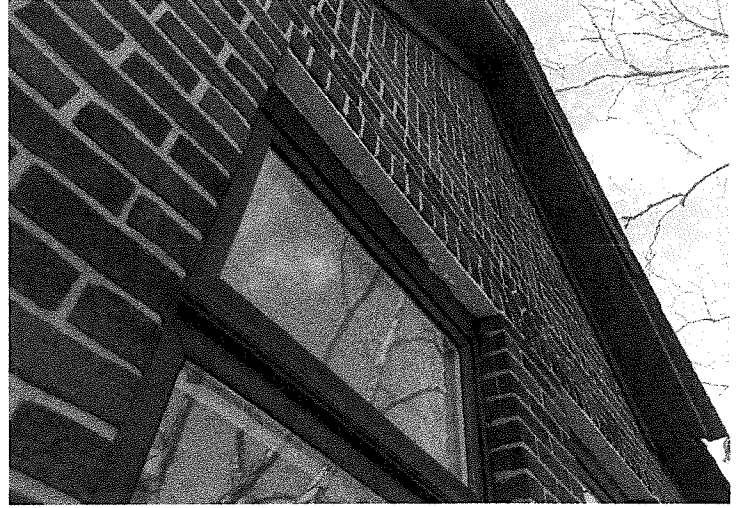
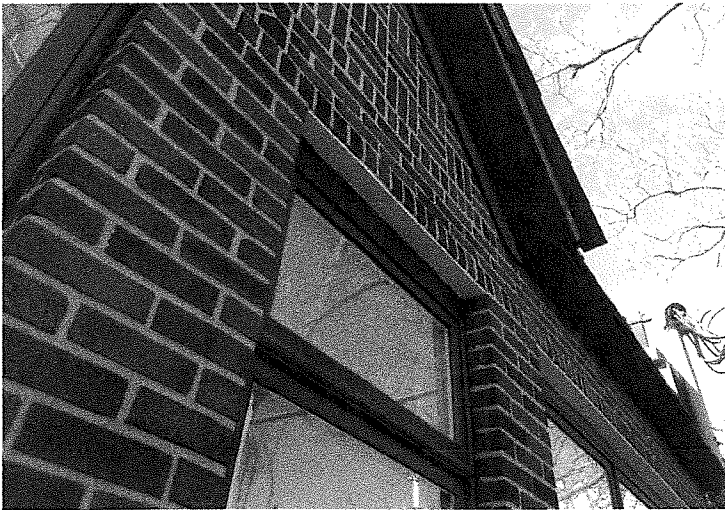
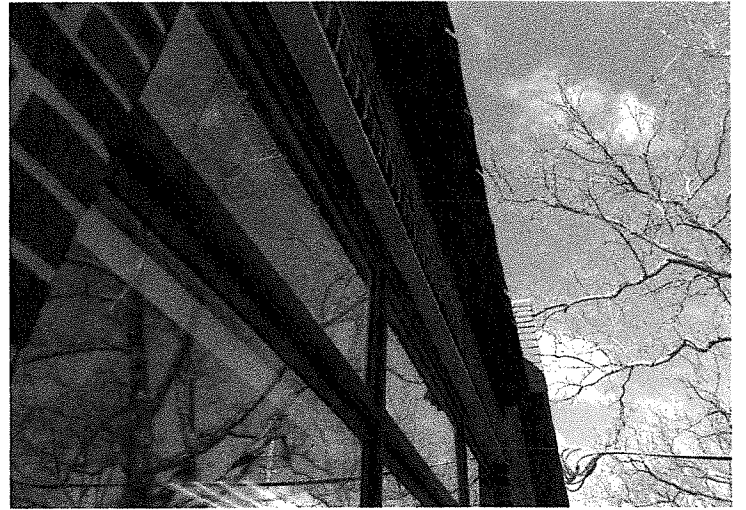
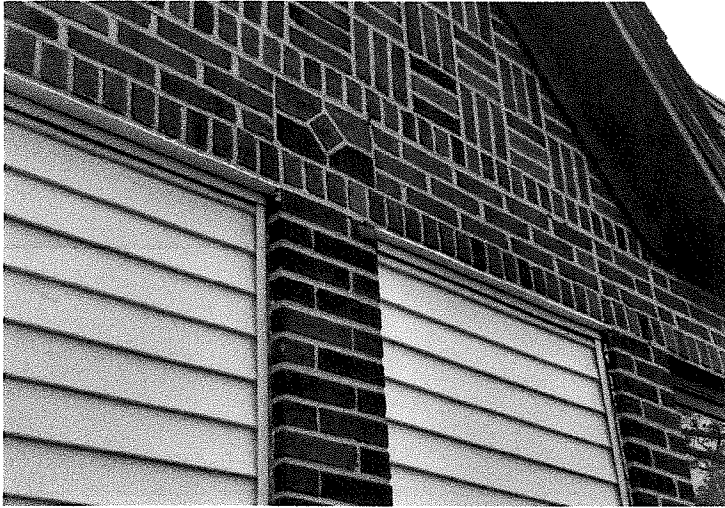
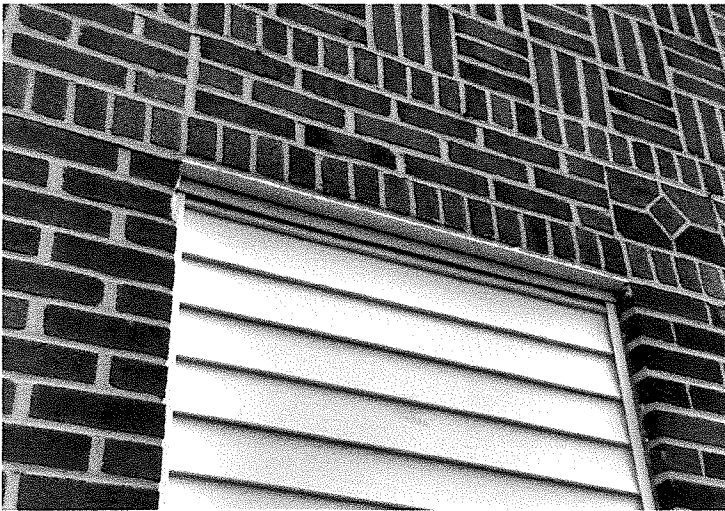
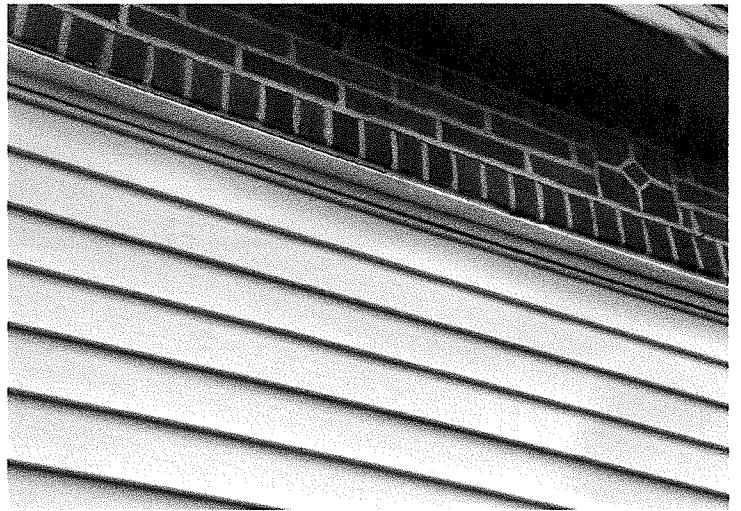
On May 4, 2021 Lew Corporation returned to the daycare facility to verify the paint stabilization of components previously failed. A visual inspection was conducted and documented through photographs, and it is noted that all deteriorated surfaces are in a satisfactory condition. No further work is necessary clearance has been achieved.

Component	Room or Work Area	Deteriorated Paint	Debris or paint chips	Pass/Fail
Window Lintels	Building Exterior	No	No	Pass
